# **Sils i. E./Segl – Val Fex, Plattensteinbruch und Steinbruchbauten (Parz. 2023)**

## **Ereignisbericht - Geländeaufnahme**

Ereignis	46015
Status	abgeschlossen
Version	1.0
Datum	08. Februar 2017

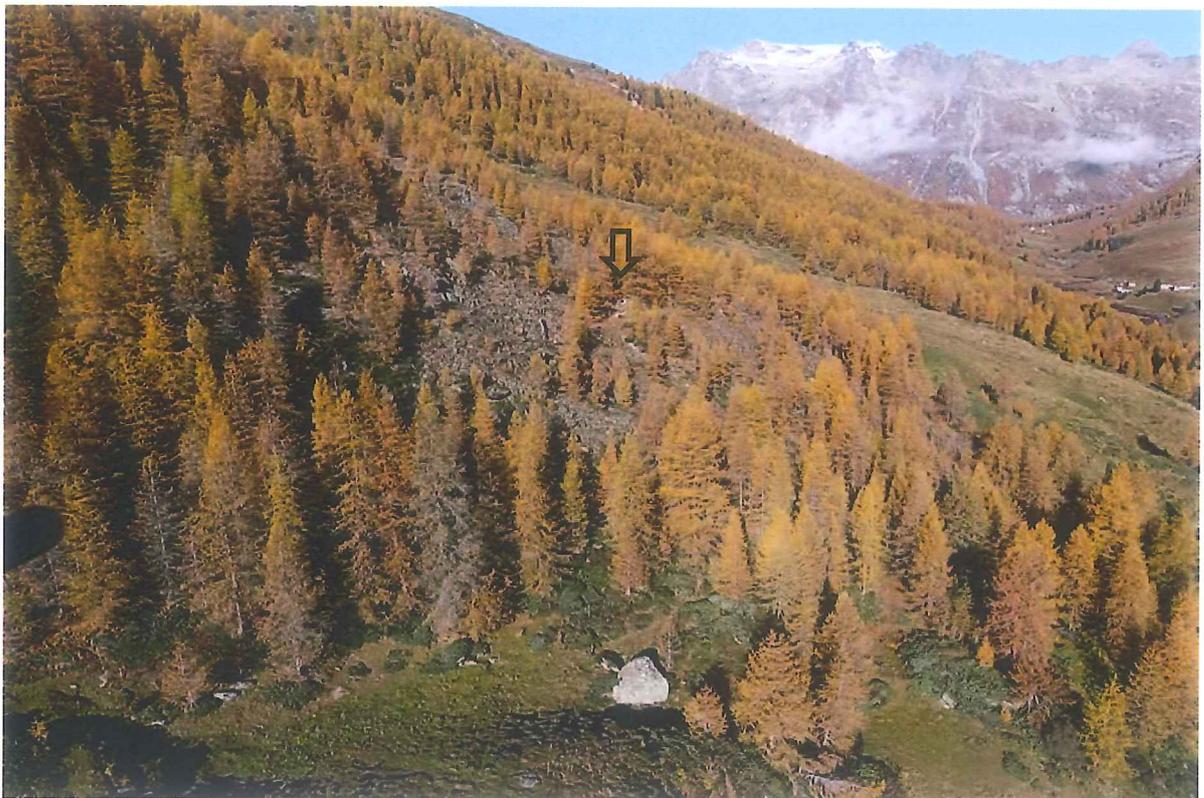
**Abbildung 1: Schrägaufnahme des Plattenbruchs. Der Pfeil markiert das Steinbruchgebäude.**

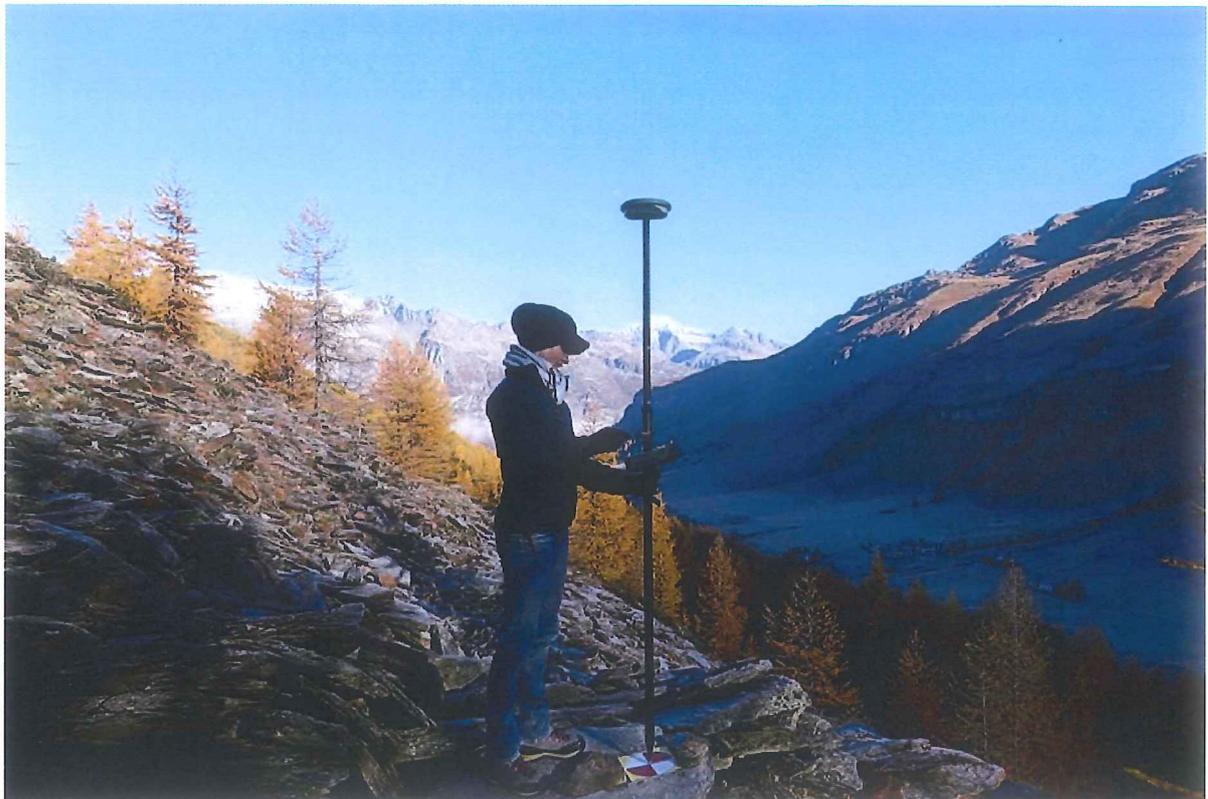
Abbildung 3: Einmessung der Passpunkte mittels Differential-GPS.

Die Geländeaufnahme wurde mittels sog. UAV-Mapping erstellt. Der ADG setzte hierfür einen ferngesteuerten Foto-Kopter (sog. "Drohne") ein, mit dessen Hilfe das Gebiet des historischen Steinbruchs systematisch abgeflogen und abfotografiert wurde. Aus den dabei generierten, vertikalen Luftaufnahmen wurde anschliessend ein Orthofoto und ein digitales Geländemodell (Oberflächenmodell) erzeugt. Die Georeferenzierung des Datensatzes erfolgte mithilfe von Passpunkten, welche mittels Differential-GPS eingemessen wurden.

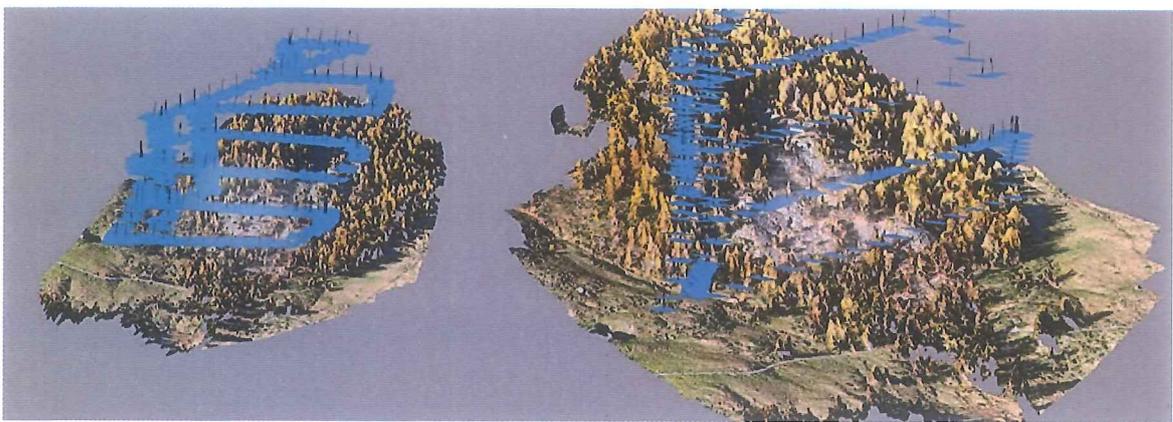
**Abbildung 4:** Beispielansichten der aus den Flugaufnahmen abgeleiteten 3D-Punktwolke. Die blauen Symbole geben die Aufnahmeposition des entsprechenden Luftbildes wieder.

Aus der auf Basis der Vertikalaufnahmen generierten 3D-Punktwolke wurden folgende Produkte abgeleitet:

- DSM – Digitales Oberflächen- (Surface) Modell
- DTM – Digitales Gelände- (Terrain) Modell
- Höhenlinien – Isolinien (1 m Intervall) für das definierte Perimeter
- Mesh – vereinfachtes, vermaschtes 3D-Oberflächenmodell zu Visualisierungszwecken
- Orthofoto

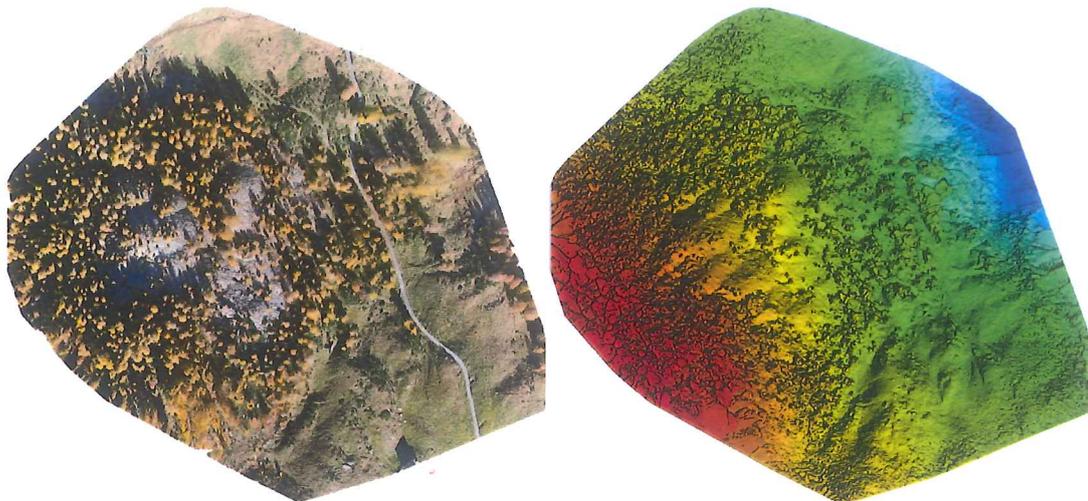
Figure 1: Orthomosaic and the corresponding sparse Digital Surface Model (DSM) before densification.

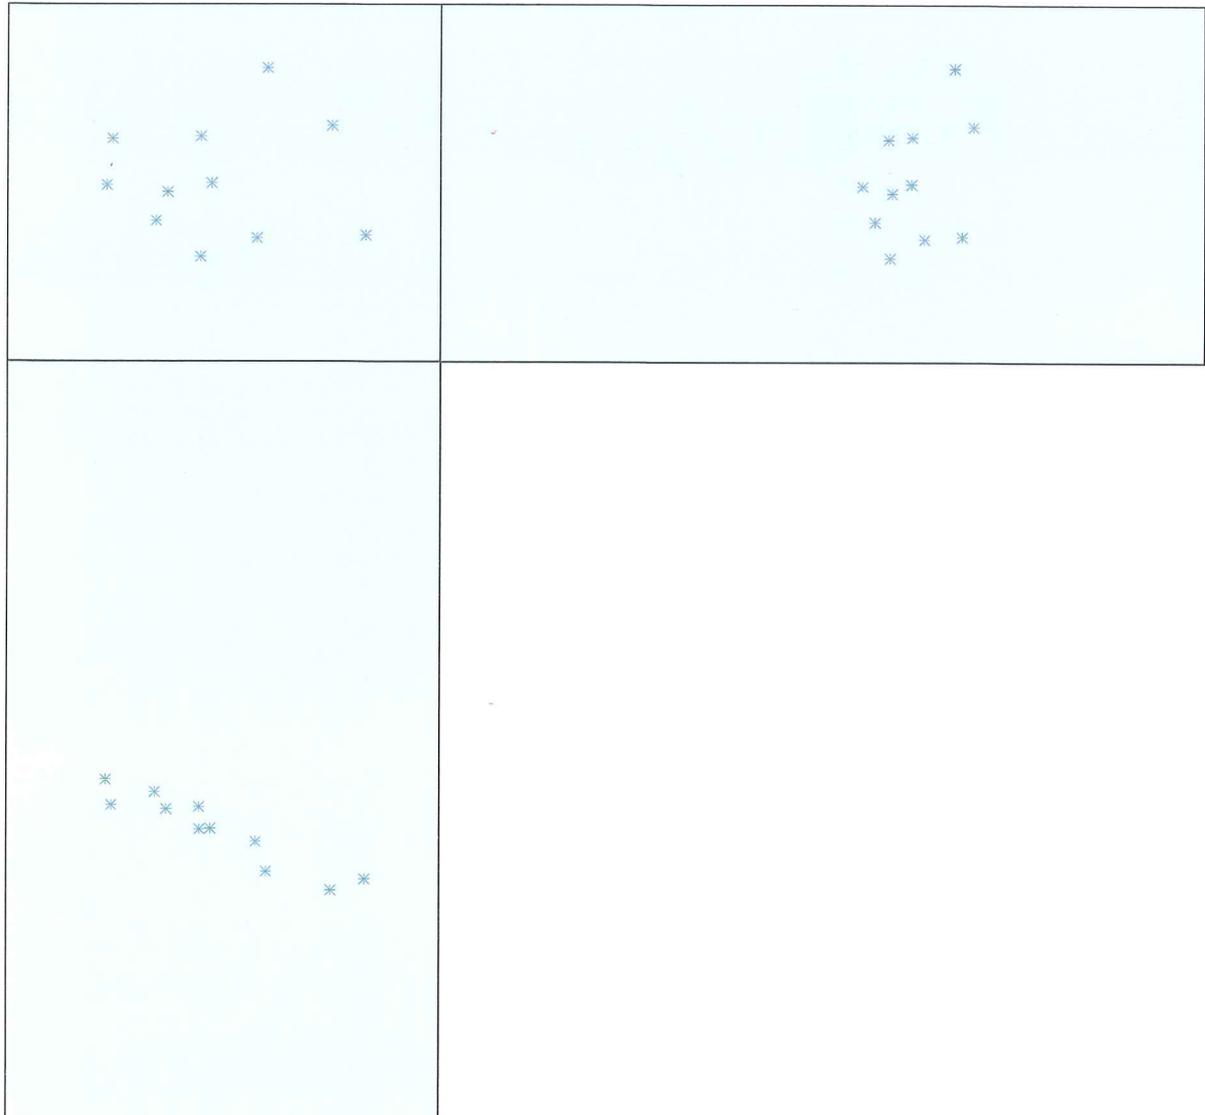
Uncertainty ellipses 100x magnified

Figure 3: Offset between initial (blue dots) and computed (green dots) image positions as well as the offset between the GCPs initial positions (blue crosses) and their computed positions (green crosses) in the top-view (XY plane), front-view (XZ plane), and side-view (YZ plane). Red dots indicate disabled or uncalibrated images. Dark green ellipses indicate the absolute position uncertainty of the bundle block adjustment result.

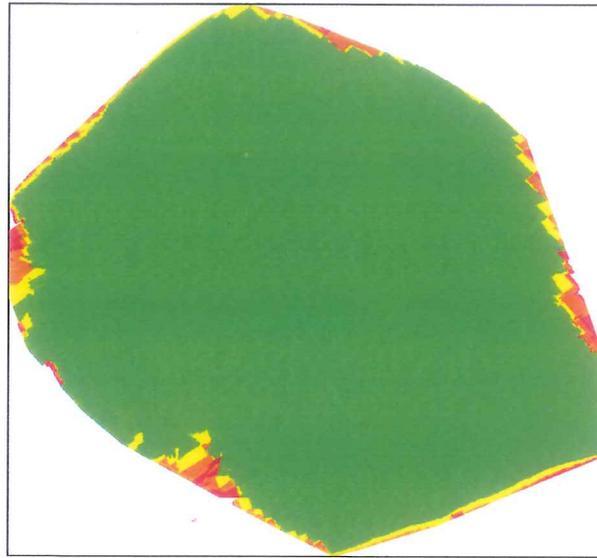
Number of overlapping images: 1 2 3 4 5+

Figure 4: Number of overlapping images computed for each pixel of the orthomosaic. Red and yellow areas indicate low overlap for which poor results may be generated. Green areas indicate an overlap of over 5 images for every pixel. Good quality results will be generated as long as the number of keypoint matches is also sufficient for these areas (see Figure 5 for keypoint matches).

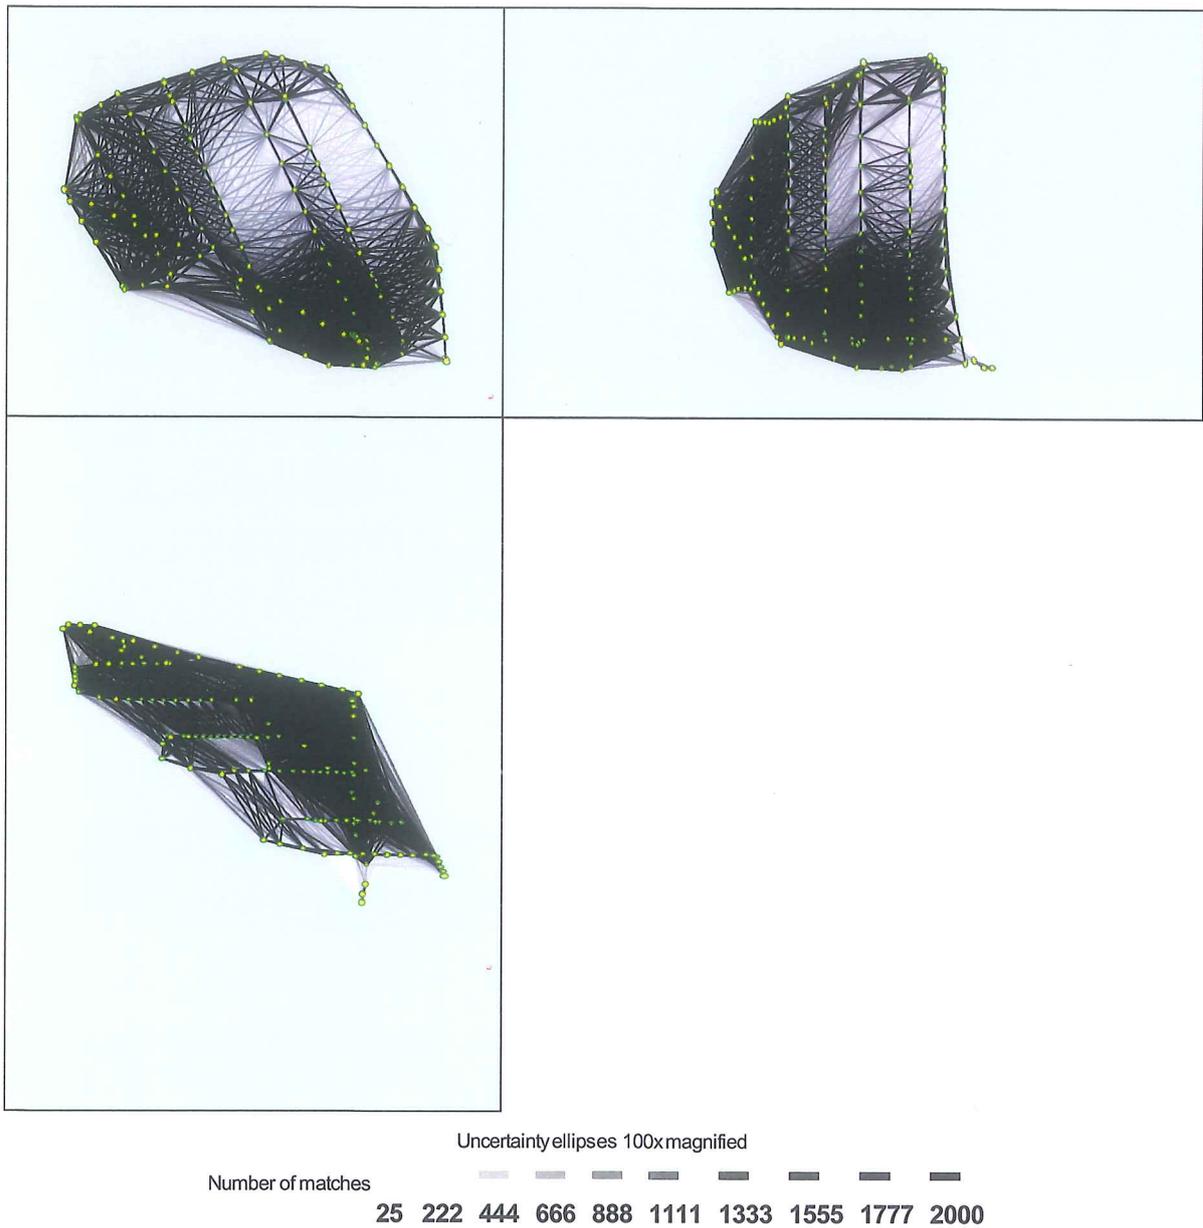
Figure 5: Computed image positions with links between matched images. The darkness of the links indicates the number of matched 2D keypoints between the images. Bright links indicate weak links and require manual tie points or more images. Dark green ellipses indicate the relative camera position uncertainty of the bundle block adjustment result.

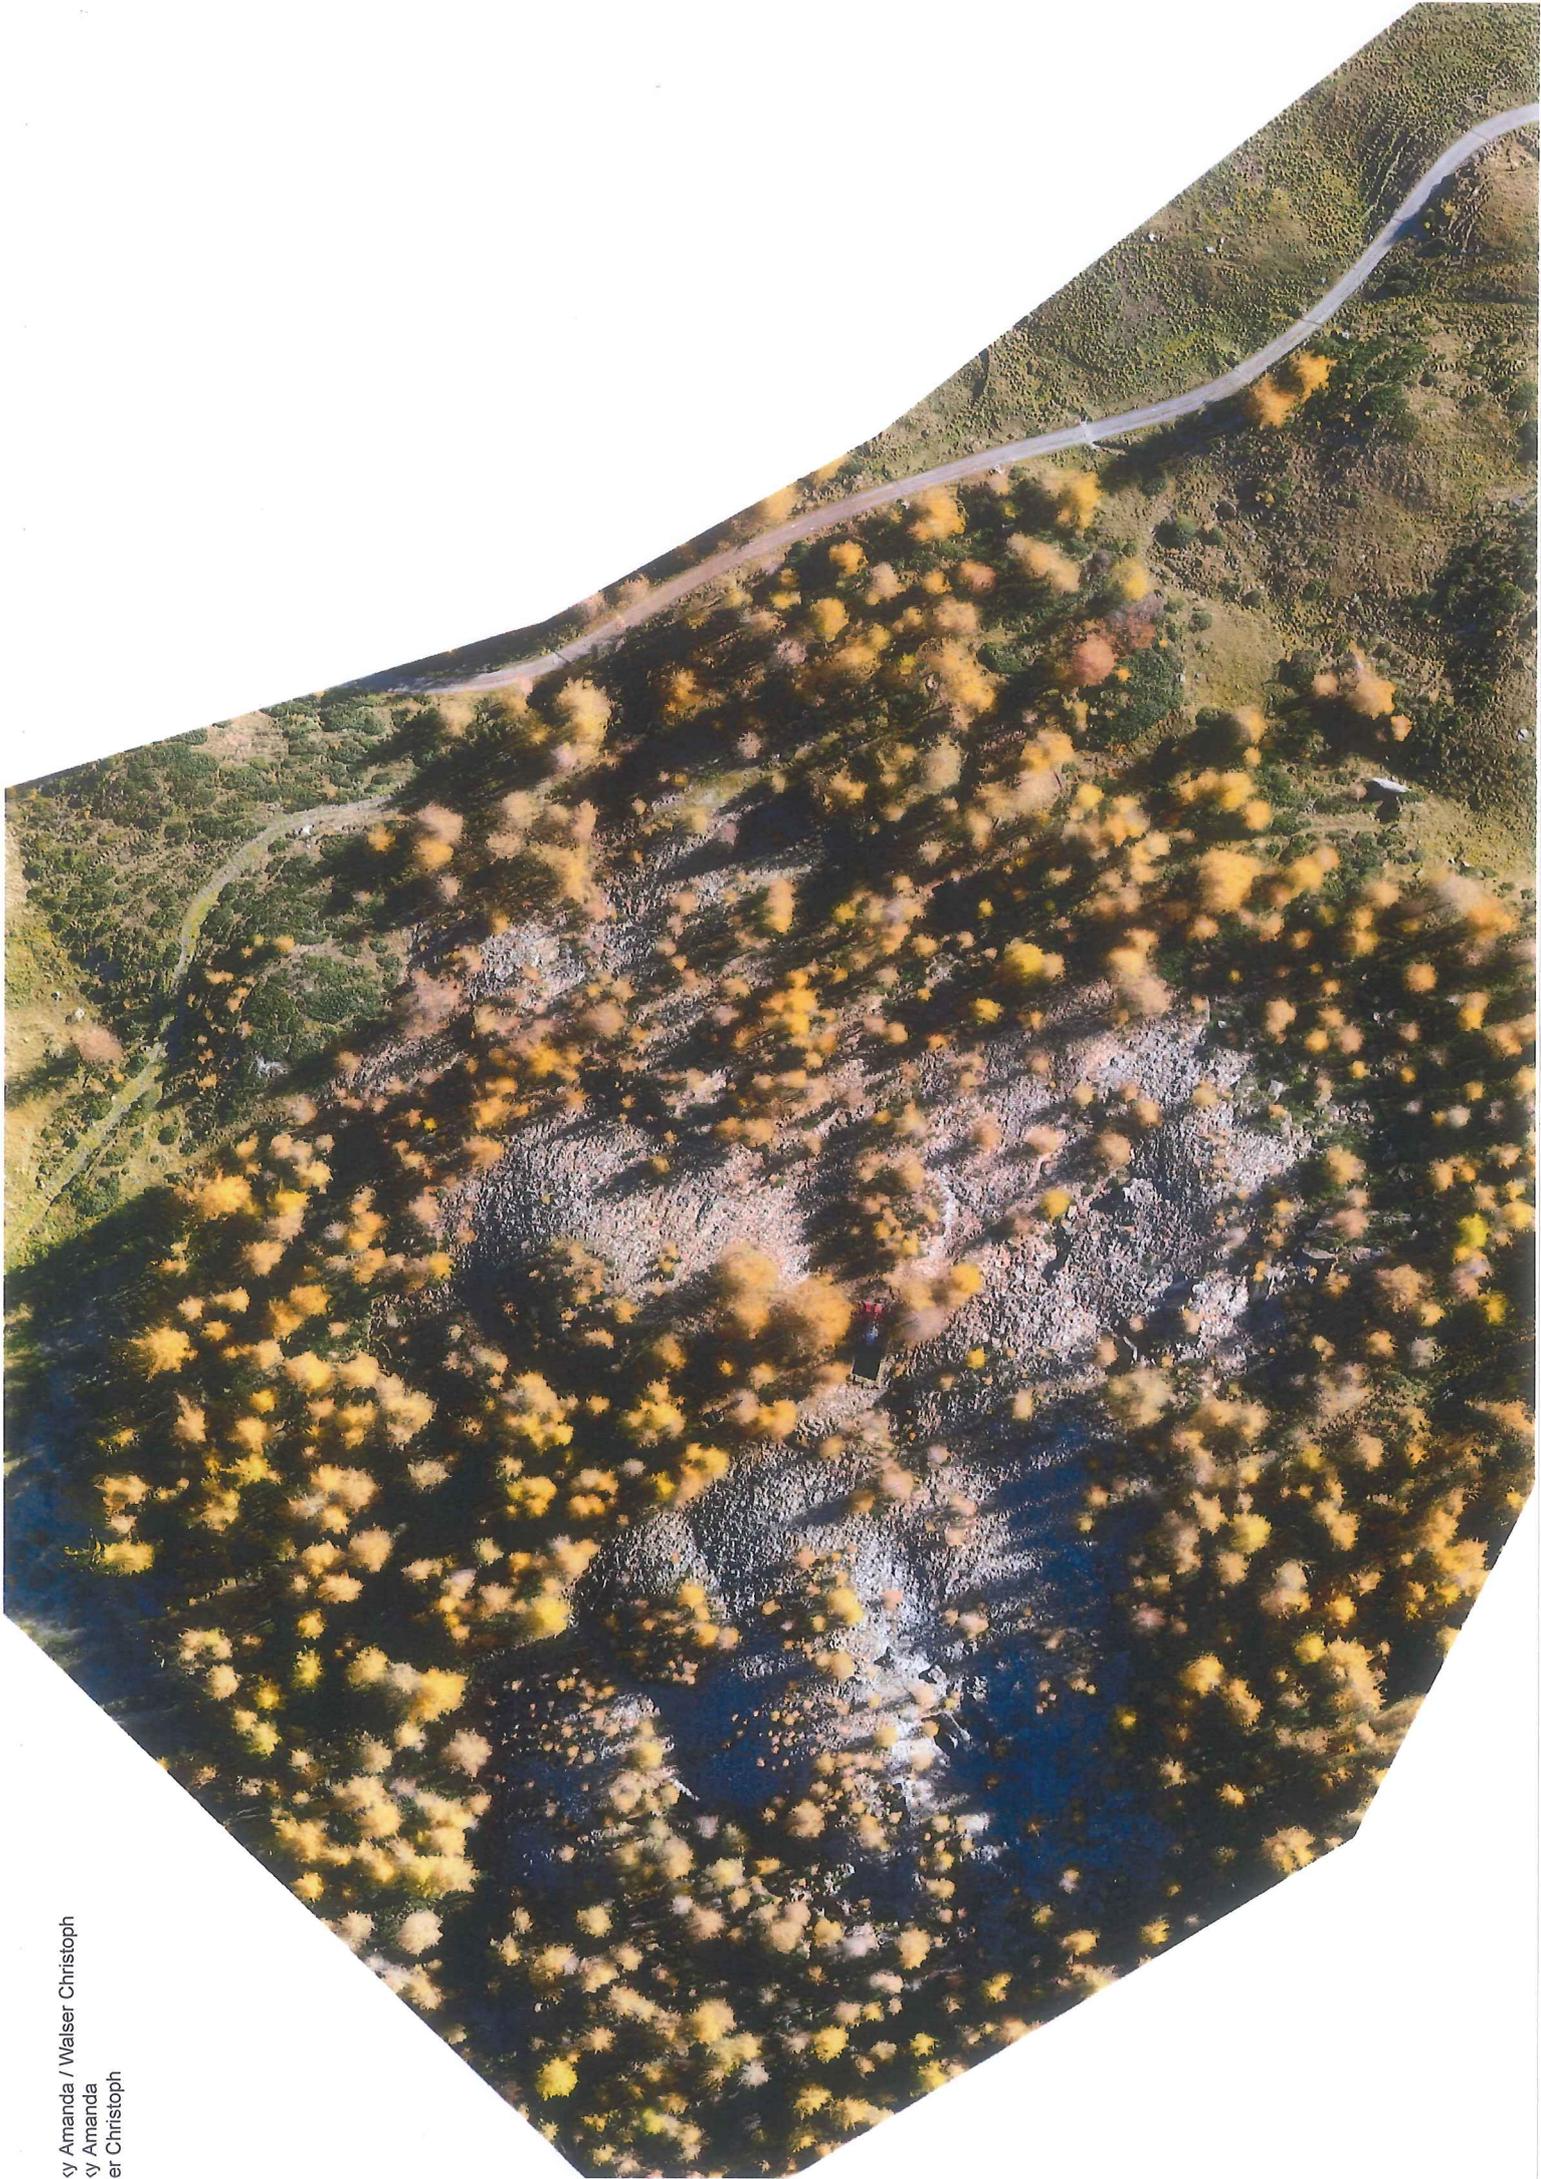
SM) - Isolinen (1m)  
Amanda / Walsler Christoph  
Amanda  
er Christoph

Zudem wurden Basispläne (P011 bzw. P012) im Massstab 1:1000 (Format: Din A3) bzw. eine Planansicht des Geländeprofiles (P013) im Massstab 1:1500 (Format: Din A3) erzeugt.<sup>3</sup>
